ASSET CONDITION REPORT MARVEL LOCH TOWNSITE

FOR THE SHIRE OF YILGARN

APRIL 2017

Document Name	Marvel Loch Sewage Scheme Asset Condition Report
Issue Date	25 April 2017
Status	Controlled

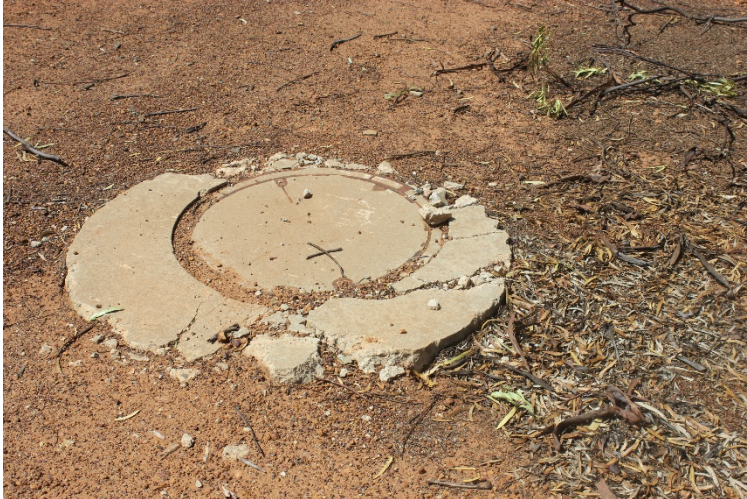
Figure 3: Access Chamber AC1A5 needs replacing

Damaged access chamber lids and erosion can be a problem for vehicles and pedestrians. Damaged lids should be replaced with erosion eradicated, and lid levels adjusted to mitigate the risk of damage to vehicles or pedestrians.

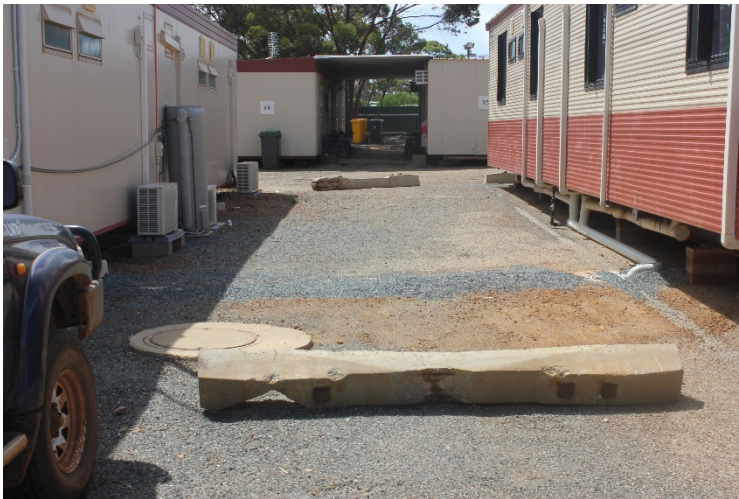
Figure 4: Evidence of no pretreatment (i.e. septic tanks) of waste within camp at AC1A7

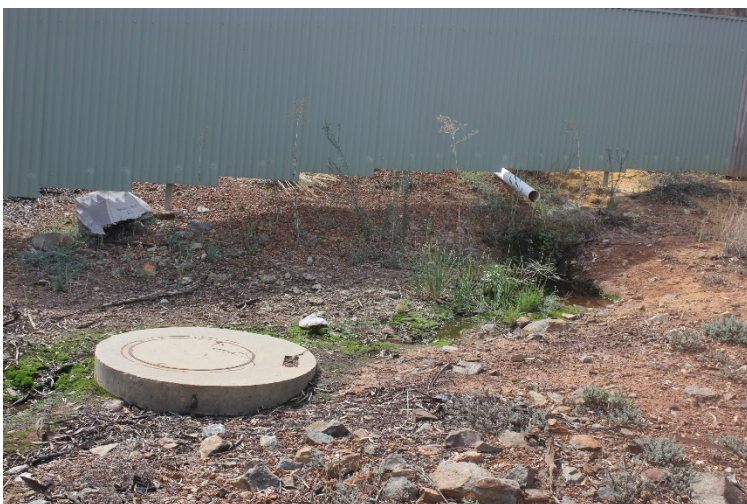
Figure 5: Overflow from camp water tank eroding around AC1B13

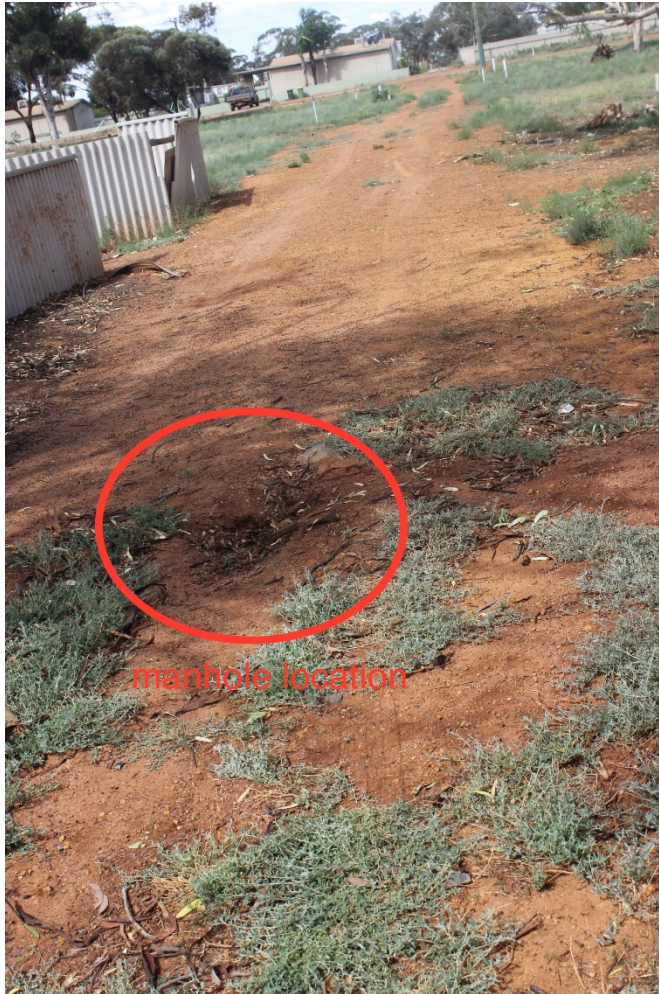
From the gravity sewer route walk, there is no evidence of any blockage resulting in the overflow of sewage. There may have been some evidence of infiltration around Access Chamber 1A18 which will need further investigation (refer to Figure 6 below).

Figure 6: AC1A18 could not be found. Evidence of erosion in area

There are a number of access chambers and inspection openings that have been covered over during the regrading of roads and laneways. It is recommended that these are located and readjusted so they are accessible in the future to reduce maintenance time if future blockages occur.

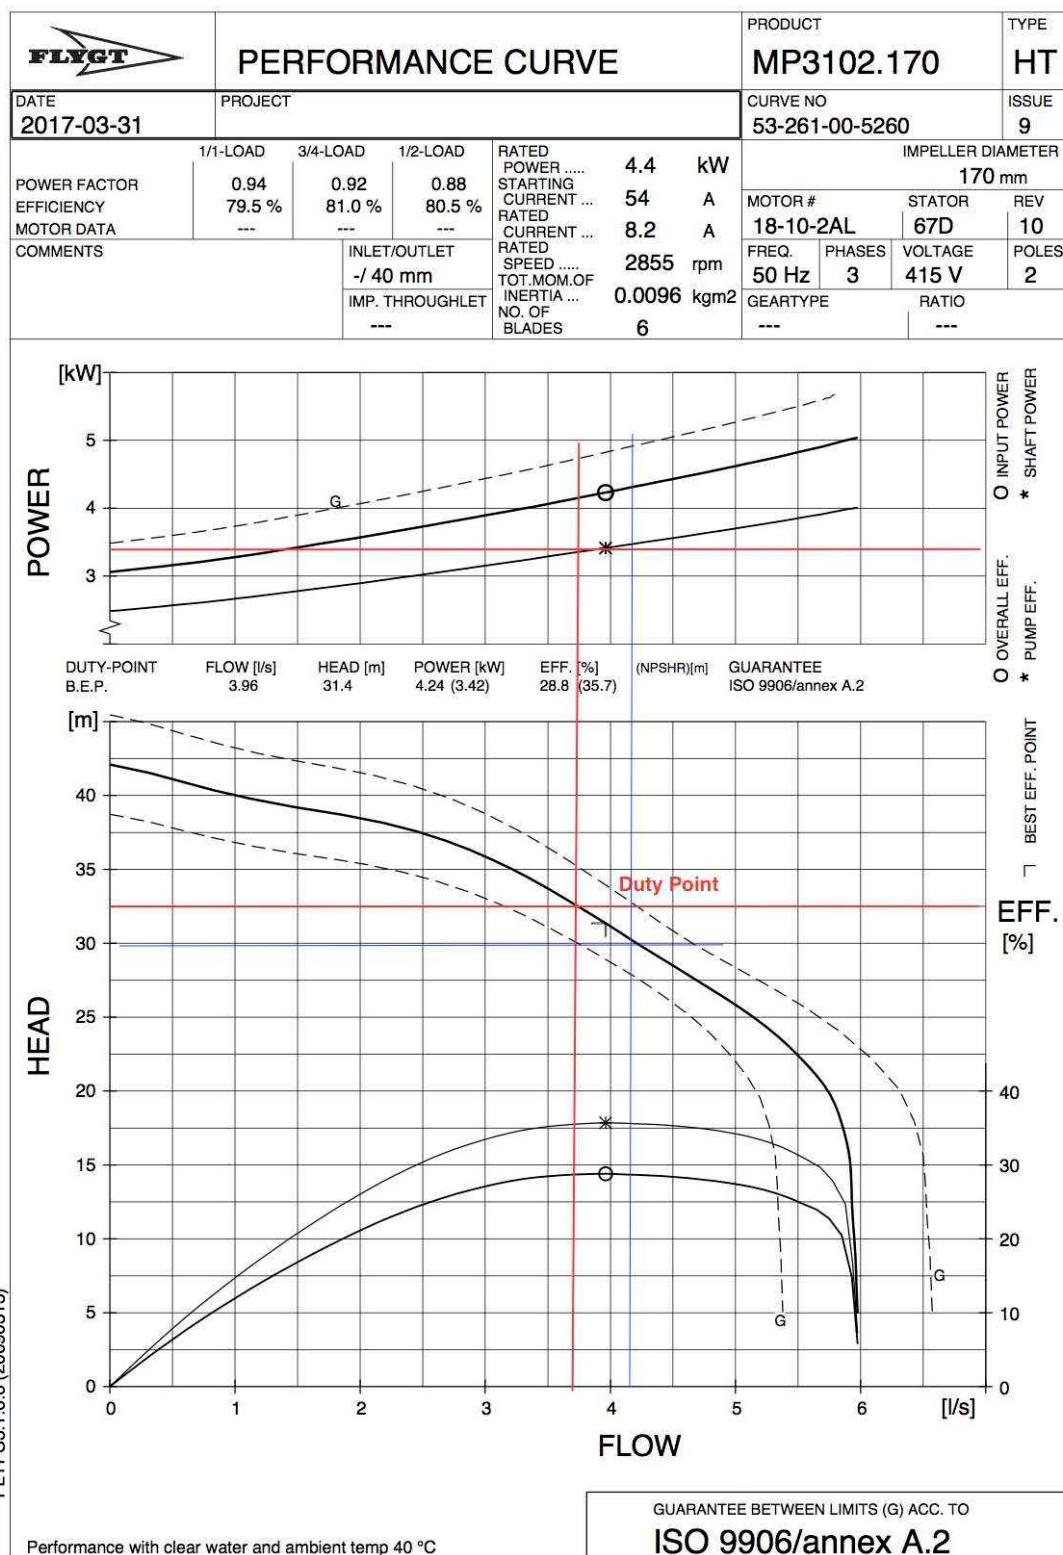
Figure 7: Pump curve of PW002 (PS2)

* This differs from the flowrate provide in the previous asset report but after further investigation is deemed correct based on the pump curve provided in figure 7 below.

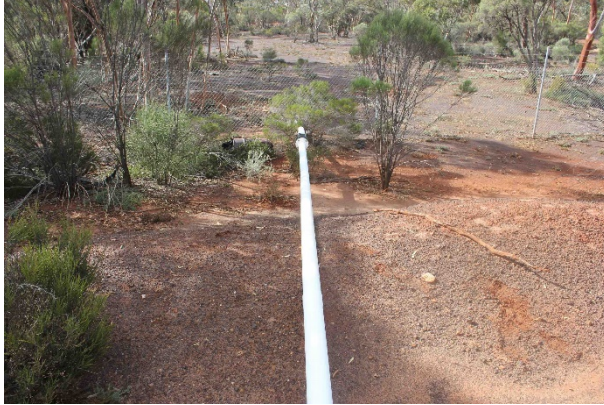
The pressure main from PW001 (PS1) entering the wastewater treatment ponds has been upgraded with two pipe materials now installed. To identify both pipe materials, we have added asset no RM0004A to Table 8 below.

Figure 8: Pressure main entering wastewater treatment ponds

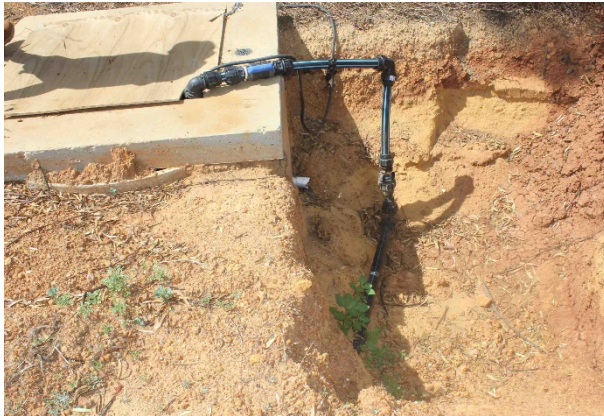
Figure 9: Temporary pressure main bypass at PW002 (PS2)

There is currently work being undertaken at PW002 (PS2) where a temporary bypass has been installed externally to the wet well. Once this work is complete, the bypass should be removed reverting back to the original set-up with the trench backfilled.

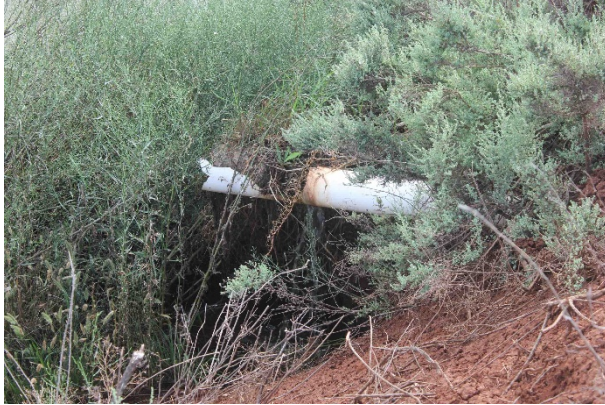
Figure 10: Broken interconnecting pipe between primary and secondary ponds

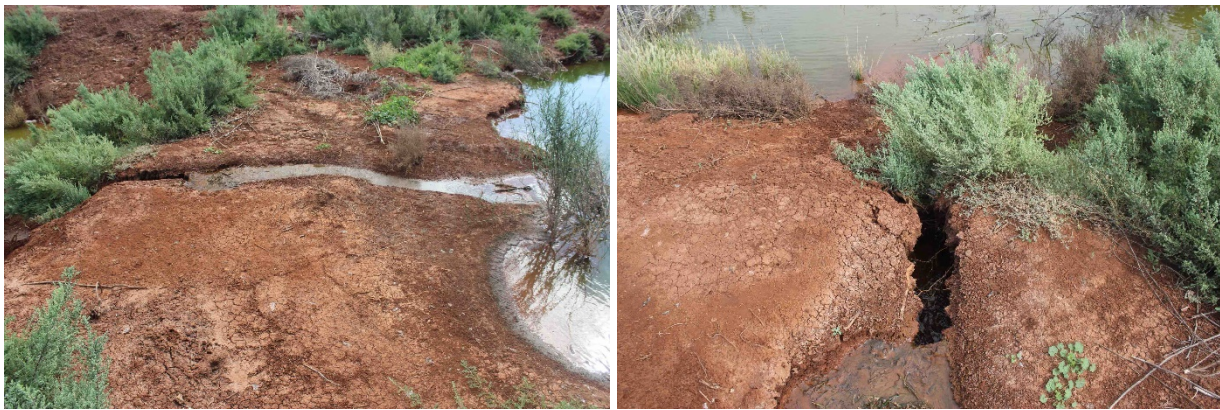
Figure 11: Erosion between primary and secondary ponds

The balancing pipe between the ponds is eroded and should be repaired before serious erosion occurs which will undermine the pond structure.

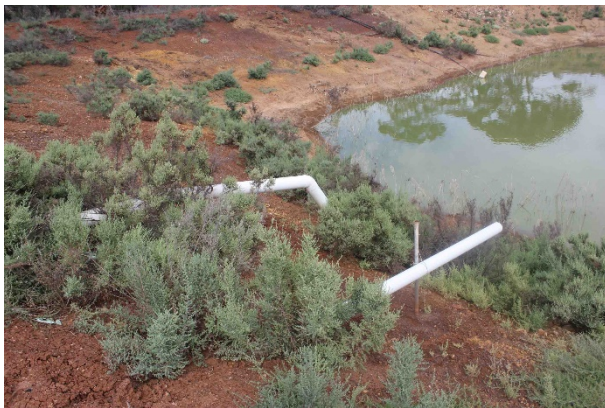
Figure 12: Blocked pipes between secondary and tertiary ponds

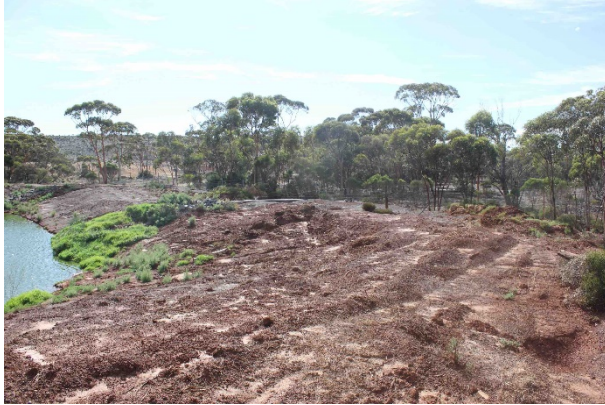
Figure 13: Access around all ponds need compacting/grading

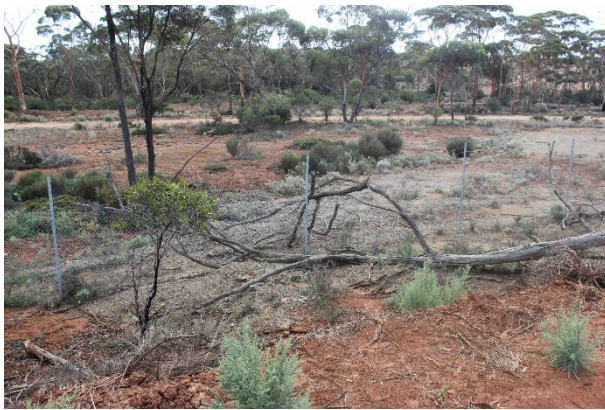
10	Fence	2	Needs fallen trees removed, and minor maintenance and tightening
11	Gate	1	Good condition and locked
12	Access	2	Road good condition Access around tank needs compaction
13	Signage	4	No hazard signs on main gate or asset signage installed

Figure 14: Damage to pond fencing

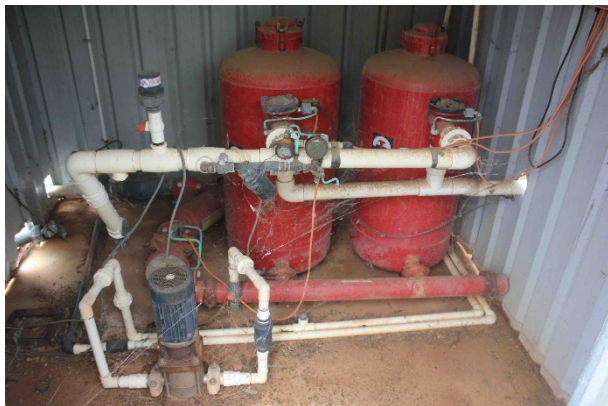
Figure 15: Reuse filtration shed

The effluent reuse system has been abandoned and much of the equipment removed.

The current system is not in use as there does not seem to be a public open space within Marvel Loch that justifies the operational and maintenance expenditure of this infrastructure. Therefore, it is recommended that the equipment is removed, cleaned and stored for future local authority use. The power feed to the shed can then be disconnected.
